**RICHVILLE DAM
VT 00074**

**PHASE I INSPECTION REPORT
NATIONAL DAM INSPECTION PROGRAM**

Identification No.: VT00074
Name of Dam: Richville Dam
Town: Shoreham
County and State: Addison County, Vermont
Stream: Lemon Fair River
Date of Inspection: August 2, 1978

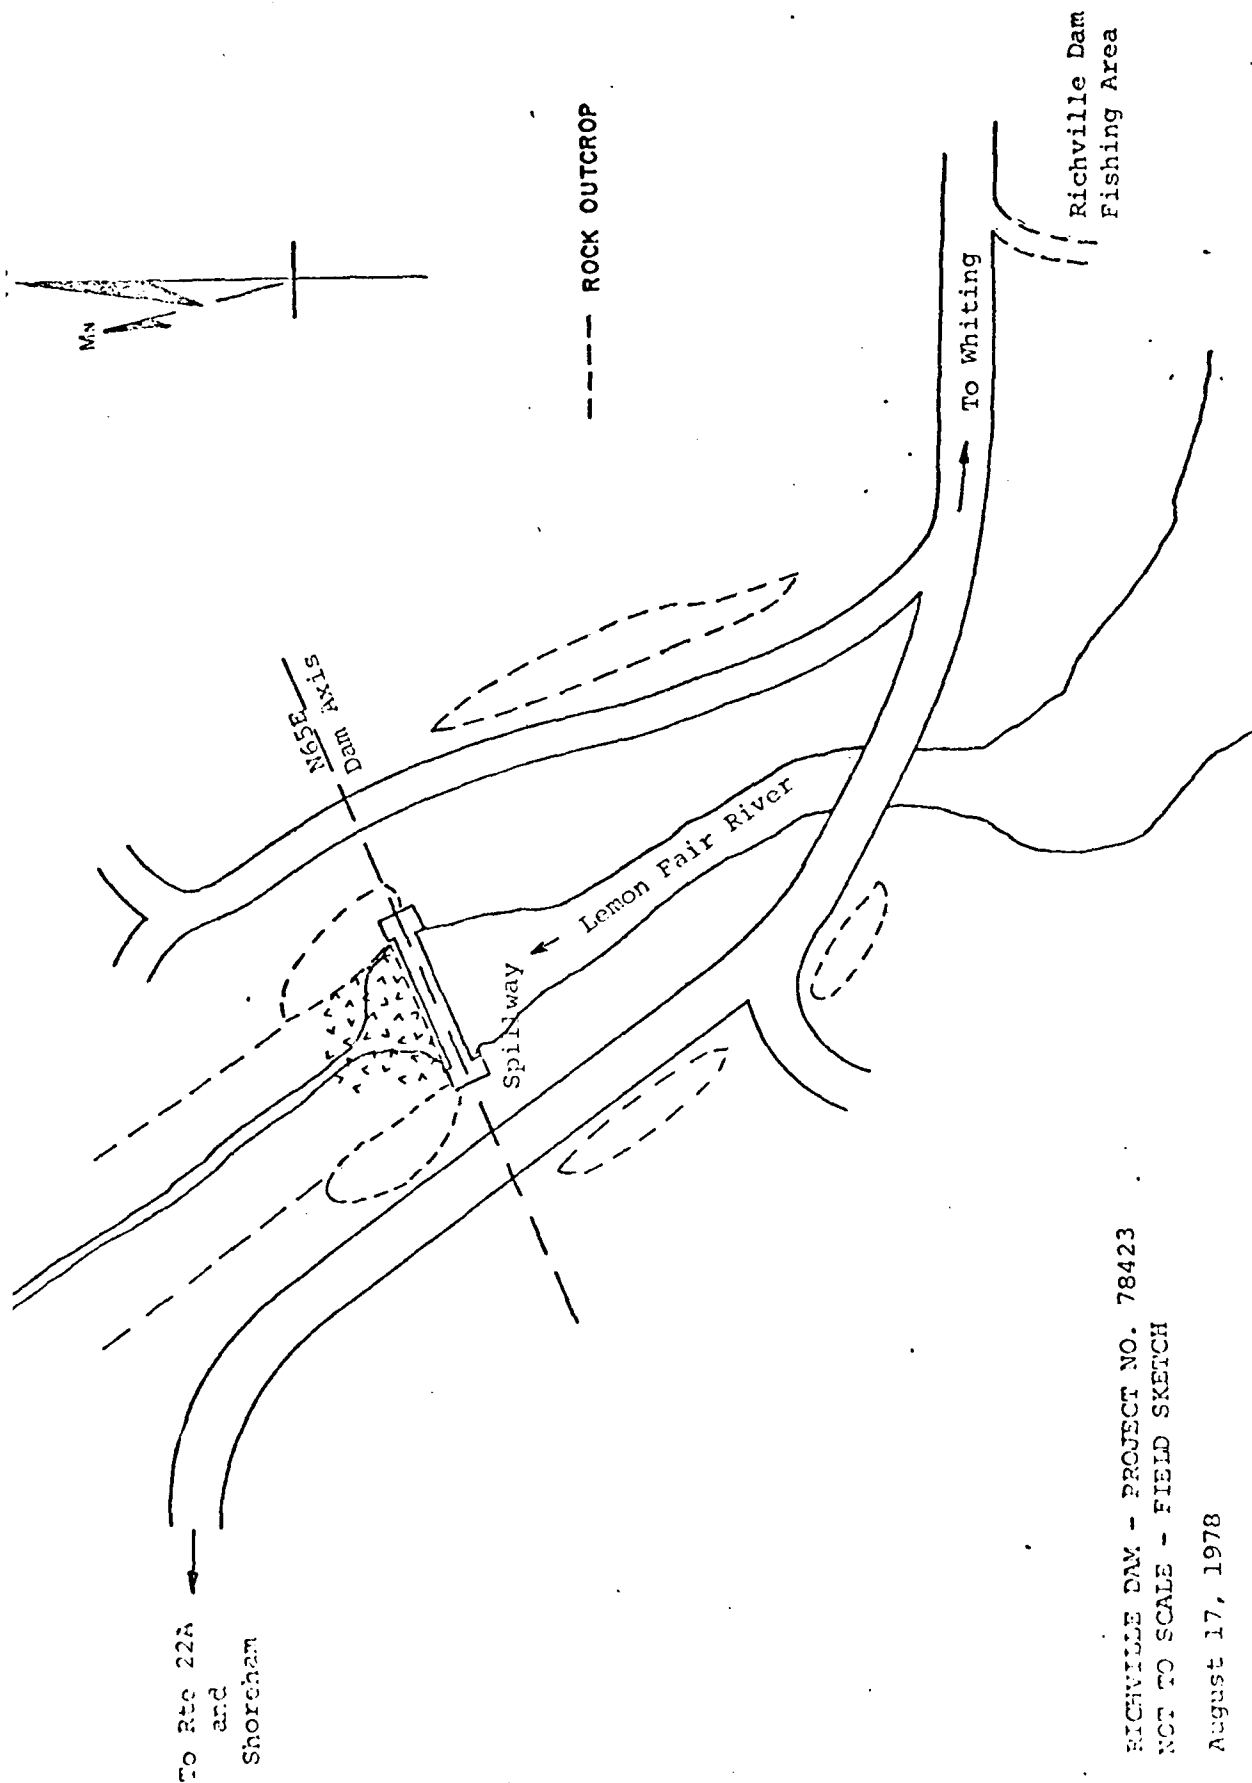
RICHVILLE DAM - PROJECT NO. 78423

A field sketch shows the rock outcrops visited in the area of the dam (see Figure 1).
